Subject: LER -2002-003-00 [Reactor Scram 104 on
June 22, 2002 Due To Loss Of Service Transformer 21]

Grand Gulf Nuclear Station
Docket No. 50-416
License No. NPF-29

GNRO-2002/00069

1. FACILITY NAME Grand Gulf Nuclear Station, Unit 1					2. DOCKET NUMBER 05000 416		3. PAGE 1 OF 6	
TITLE (4): Reactor SCRAM Due To Loss Of Service Transformer 21.

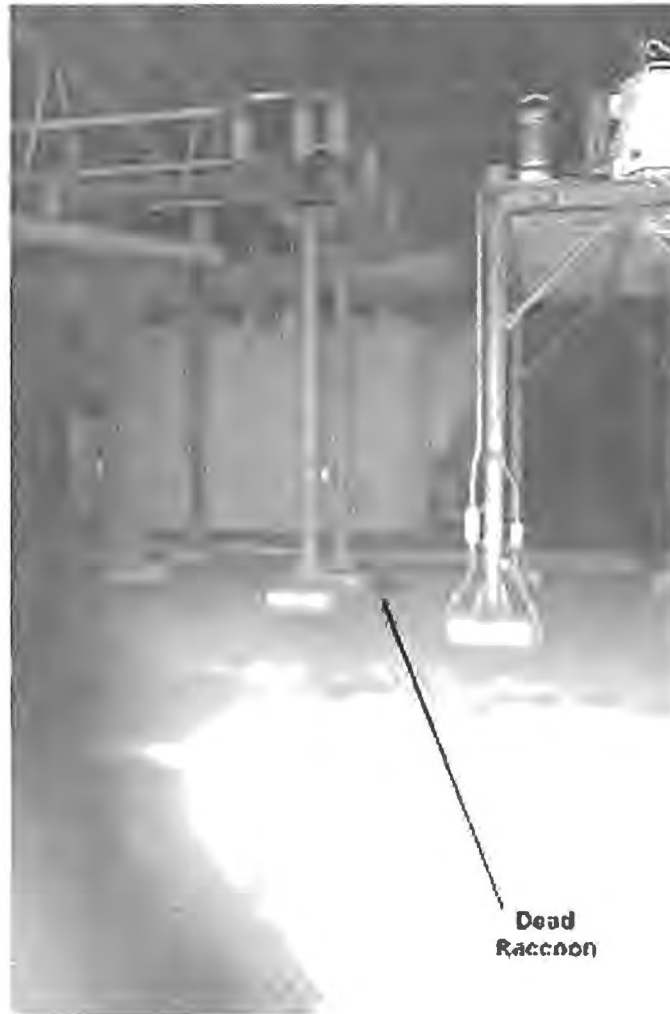
The ground fault was the result of a raccoon bridging the 34.5 KV phase "B" to a grounded stanchion in the vicinity of switch 589-21GT. This switch is a manually operated disconnect switch, located electrically between the secondary of ST21 and the Grounding Transformer for ST21. ST21 is a 500 kV (primary) to 34.5 kV (secondary) transformer. (See Attachments 1, 2 and 3).

**Pictures of dead Raccoon after bridging the 34.5 kV phase "B" to a ground stanchion
On June 22nd, 2002 at Grand Gulf Nuclear Station
(Attachment 1)**

- a. Service transformer protective relaying was verified to be functioning correctly. Checks were made of the service transformer and related equipment to verify no damage was done to any switchyard components. The service transformer was subsequently re-energized without incident.

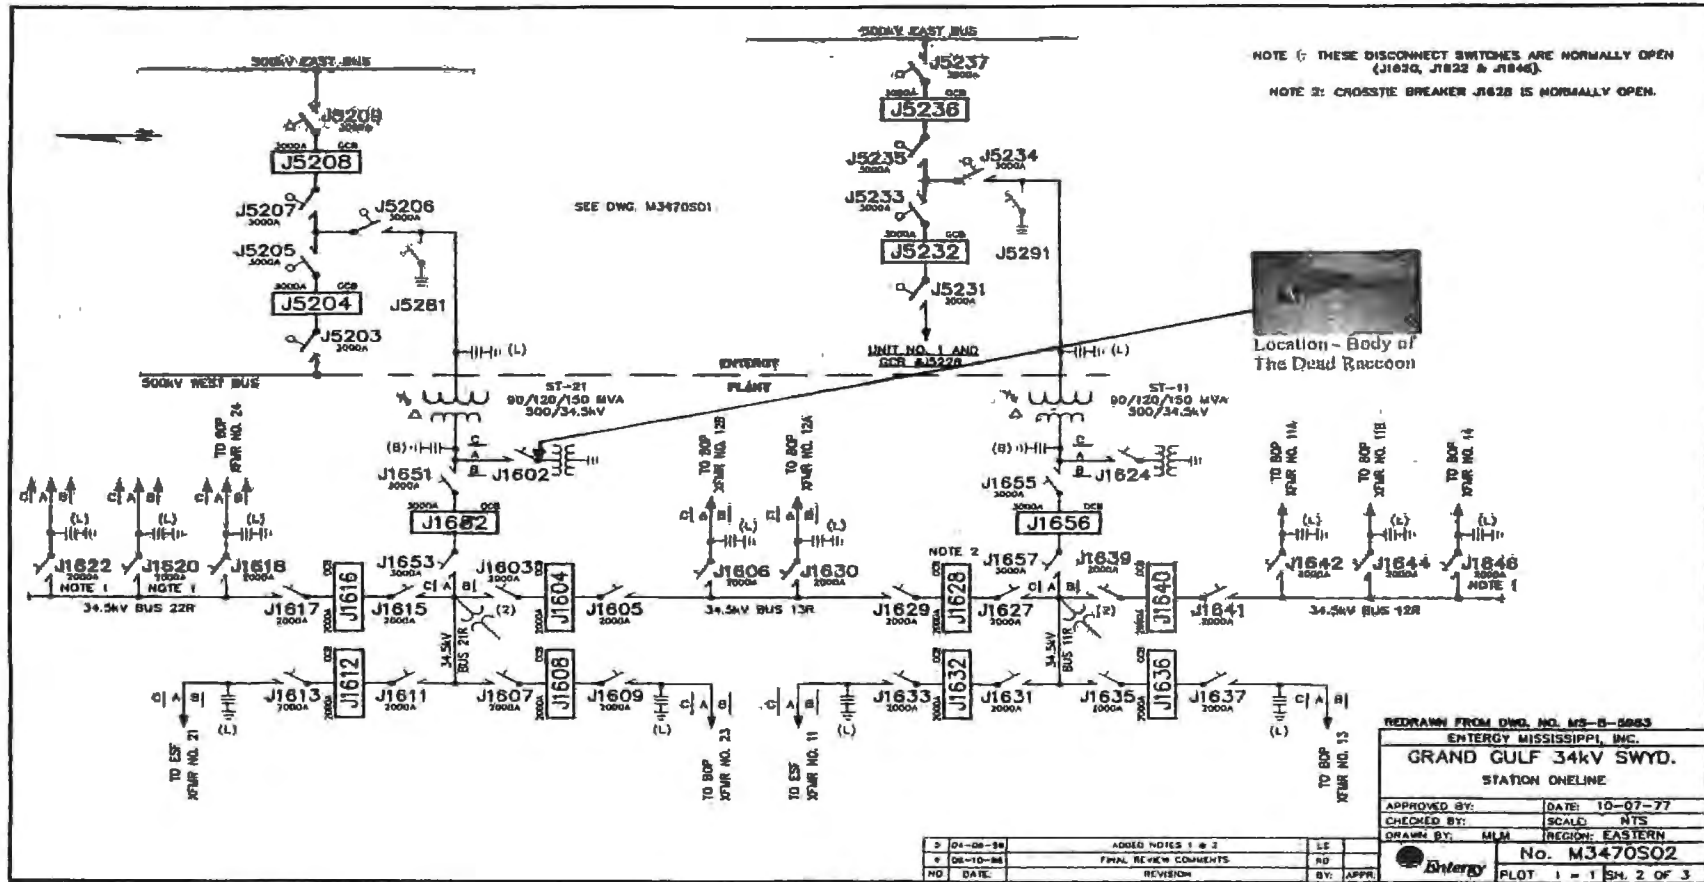
LER 2002-003
 Attachment 2

Entergy Mississippi, Inc.
Grand Gulf 34kV Switchyard
Location of the dead Raccoon
